ENCLOSURE 2 TO AEP-NRC-2014-59

I&M CAP Document AR 2010-1804-10, Root Cause Evaluation Attachment, "Rx Vessel Core Support Lug Bolting Anomalies"

**Root Cause
Evaluation of Unit 1
Rx Vessel Core Support Lug
Bolting Anomalies**

**(AR 2010-1804-10)
March 21, 2010**

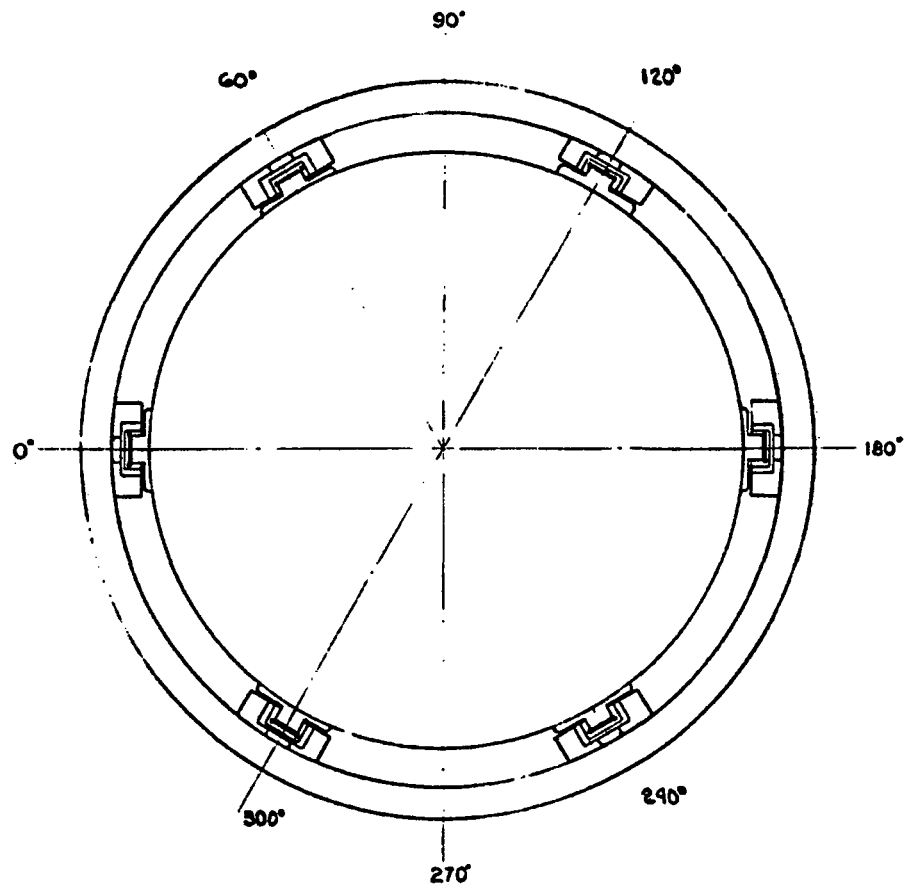
Figure 1: Plan view of LRSS

consists of six support locations equally spaced around the bottom circumference of the RV (60-degree spacing), see Figure 1 and Figure 2. Each support location consists of the following:

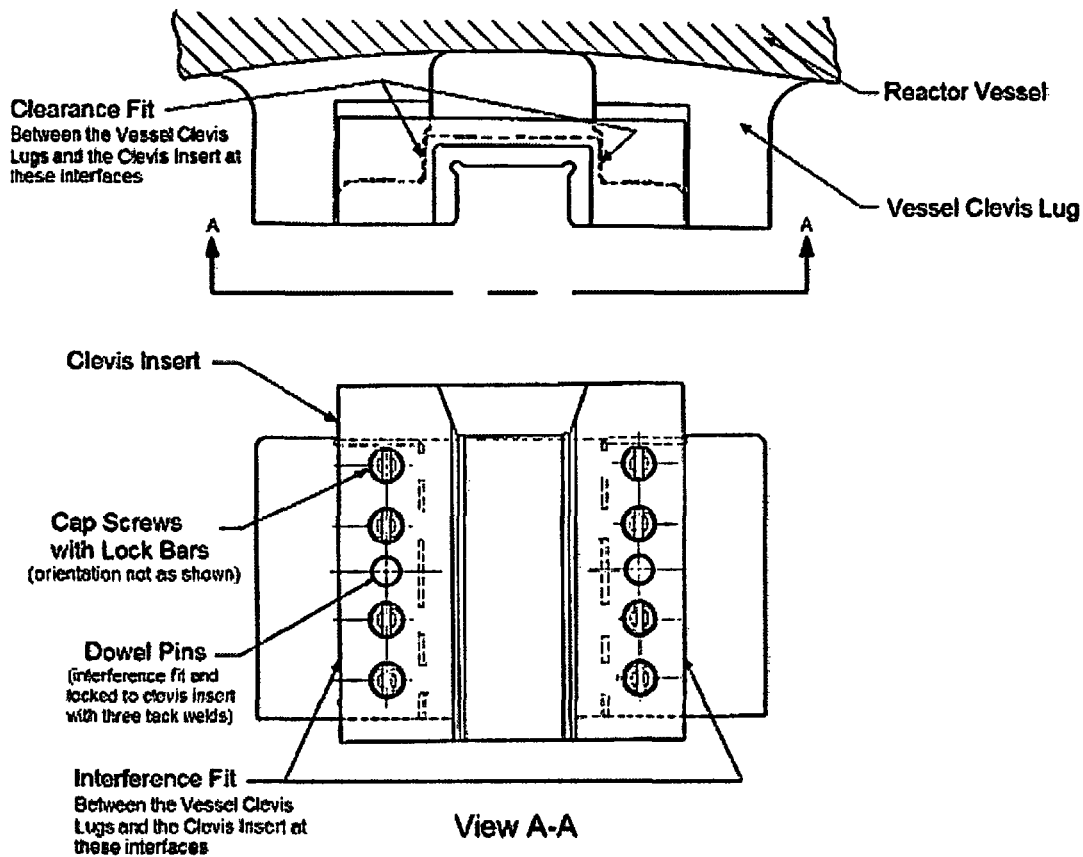
Figure 4: As-designed Clevis Insert Installation

See Figure 3 for the interface between the RSK and the clevis insert. For the D.C. Cook design, each core barrel clevis insert contains eight bolts (cap screws), for a total of 48 bolts. These bolts are restrained from rotation by a welded lock bar at each bolt location. In the event that a bolt fails, the lock bar design captures the bolt and keeps it in place to prevent a loose parts condition. Each insert location also contains 2 dowel pins, for a total of 12 pins. The clevis insert dowel pins provide added, possibly redundant, retention of the insert from long term vibratory motion. The interference fit of the pins keeps the insert from having small displacement slippage in the upward direction over time. They also help to prevent the clevis from sliding upward during core barrel removal. This prevents production of bending stresses in the bolt shanks if the clevis should shift. The clevis insert design and bolts prevent motion in other directions. Table 1 describes the bolt, lock bar, and dowel pin materials and sizes. Figure 4 illustrates the as-designed installation of the clevis inserts at D.C. Cook.

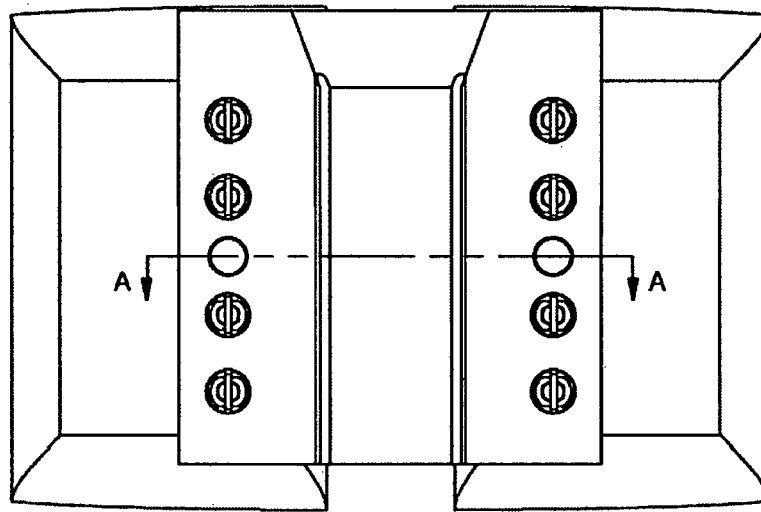
Figure 7: LRSS Clevis Insert and Lugs

Figure 7 shows an overview of the clevis insert and the location of cross section for the following two figures. Figure 8 shows an exaggeration of how the clevis insert would deflect under radial loading with intact bolts. Figure 9 shows an exaggeration of how the clevis insert would deflect under radial loading with failed bolts [Exhibit 94].
